NASA CR-188258

Final Report

THE MAGNITUDE OF IMPACT DAMAGE ON LDEF MATERIALS

Martha Allbrooks and Dale Atkinson  
POD Associates, Inc.  
2309 Renard Place, S.E.  
Suite 201  
Albuquerque, New Mexico 87106

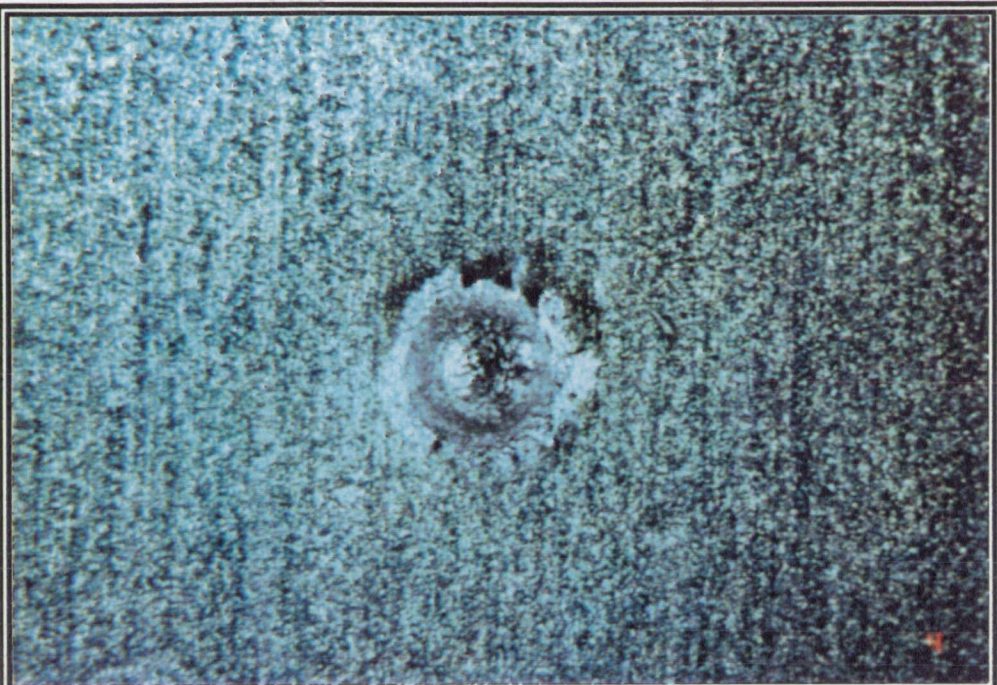
**Figures P2-1a and P2-1b (S90-44982 and KSC-390C-2038.4)** are typical of hypervelocity impacts into aluminum surfaces. Figure P2-1a shows an impact which has a symmetrical hemispherical crater characteristic of all impacts into aluminum surfaces. Here the typical symmetrical lips stand above the surface of the aluminum. Figure P2-1b is a picture of the back surface of the S0001/A0189/A0172 experiment tray, located at LDEF Bay D02, showing the spallation (removal) of black paint caused by a front surface impact. Spalled material can cause additional internal damage to satellite components or become a contamination source, as described later in Section 2.5.

**Figure P2-1a.** Photograph of a typical hypervelocity impact feature in aluminum.

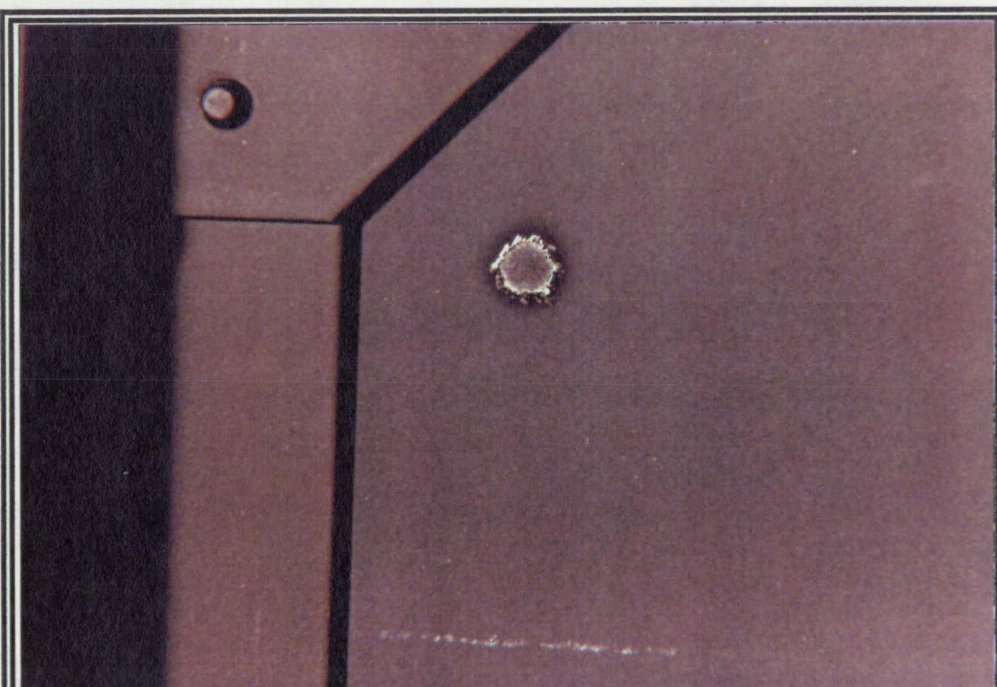
**Figure P2-1b.** Photograph of a spallation feature on the back surface of the experiment tray located at Bay D02.

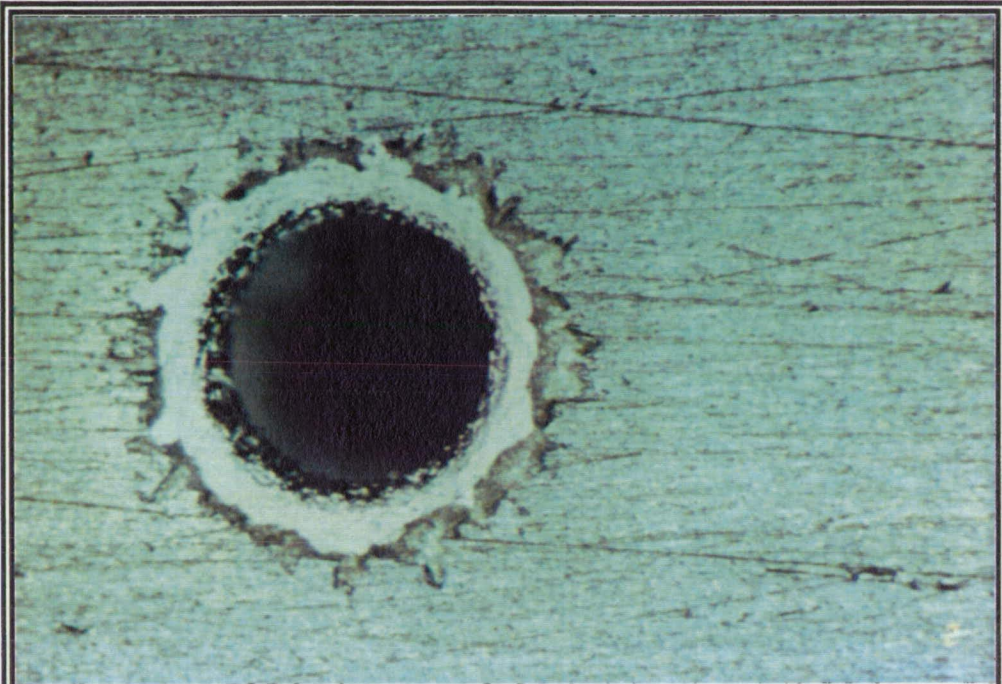
**Figure P2-2 (S90-44980)** is a picture of a penetration through an aluminum panel on LDEF, and is typical of penetrations at hypervelocity speeds. It is a symmetrical penetration hole with lips which are also symmetrical. This feature is the back surface exit hole made by the impactor through the aluminum. The front surface (opposite side of this plate) of this feature is a penetration through a painted aluminum plate. A picture and discussion of the front surface of this feature is included in Section 2.2.2 under Figure P2-38. These types of penetrations provide

**Figure P2-2.** Photograph of a penetration through a painted aluminum panel on LDEF.

a substantial amount of secondary ejecta and an expanding debris cloud of solid, liquid, or gaseous particulates which can cause damage to other materials located immediately behind the surface. Loading pressures on internal components located approximately an inch away from the penetration could approach as much as 50 kilobars.

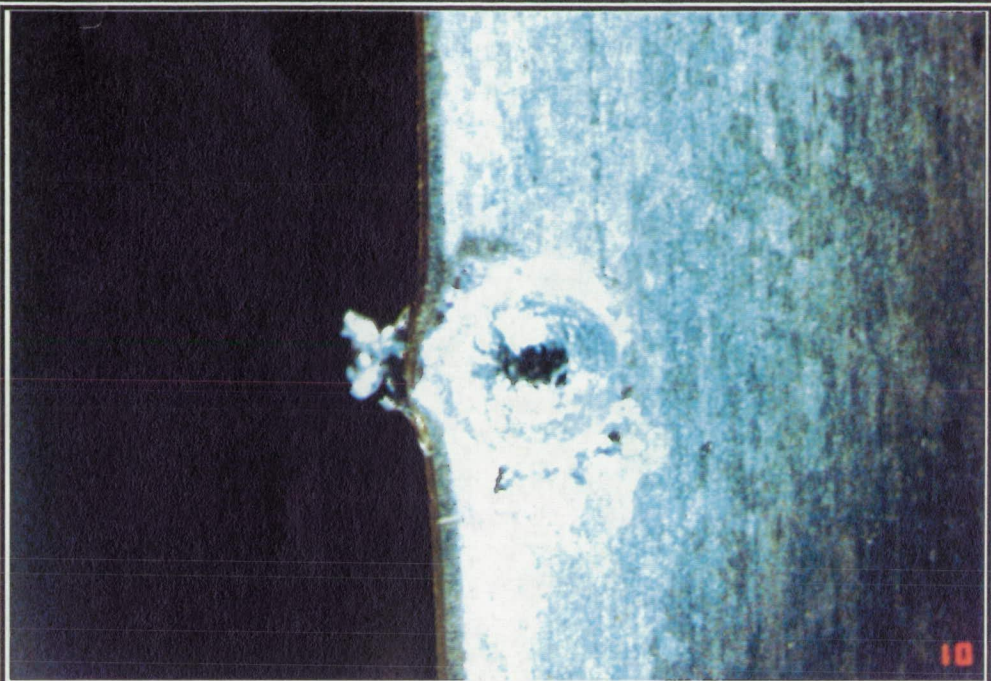
Highly-oblique impacts were found in large numbers on LDEF, particularly on the Earth- and space-facing ends of the spacecraft, but were also found on all other surfaces of LDEF. Very oblique impact surface damage areas are much larger (but shallower) than those caused by normal incidence impacts. These highly-oblique impact craters are often accompanied, as in Figure P2-6, by a large amount of ejecta, which causes various spray patterns and contamination to nearby surfaces. These multiple cratering events cannot currently be duplicated in ground-based experiments nor can they be predicted using the current models.

**Figure P2-3.** Photograph of an impact feature into the edge of an aluminum plate.

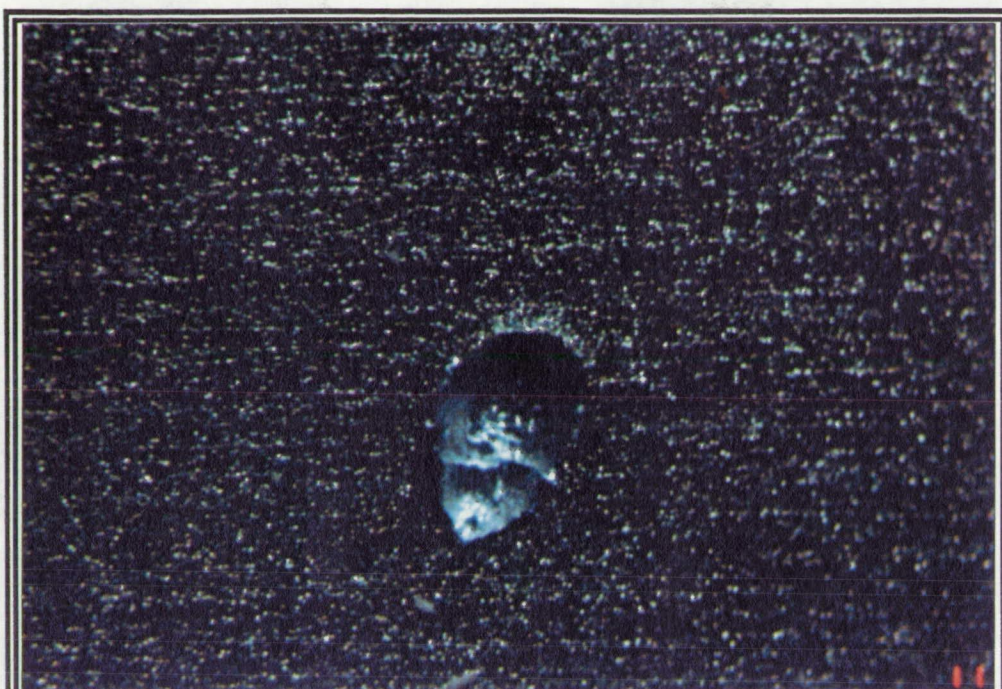
**Figure P2-5.** Photograph of a multi-cratering impact feature in an aluminum surface.

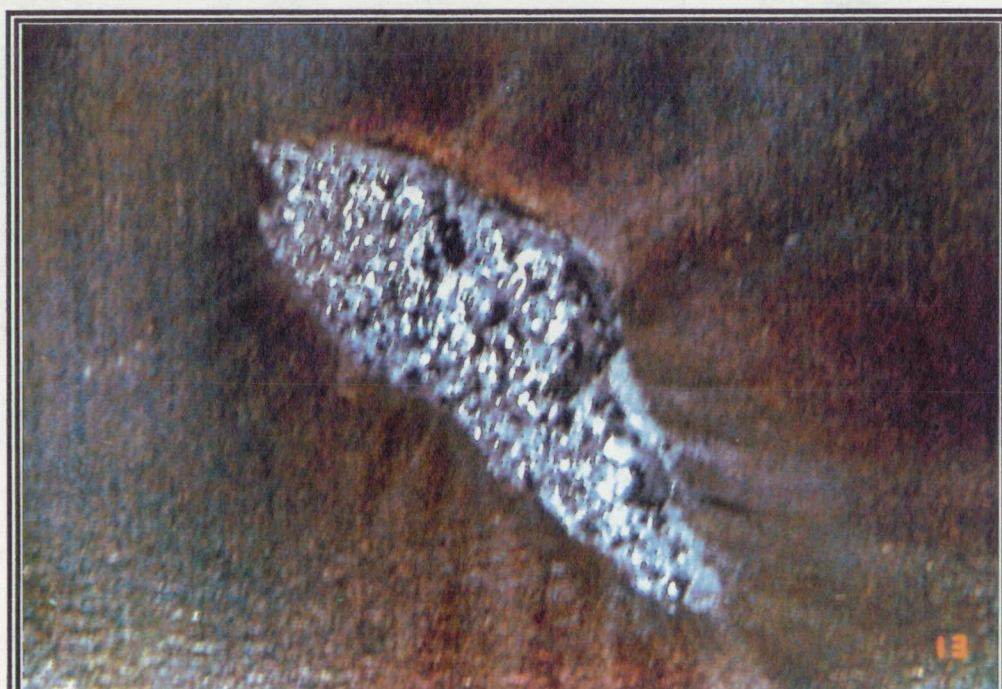
**Figure P2-6.** Photograph of a multi-cratering impact feature in an aluminum surface.

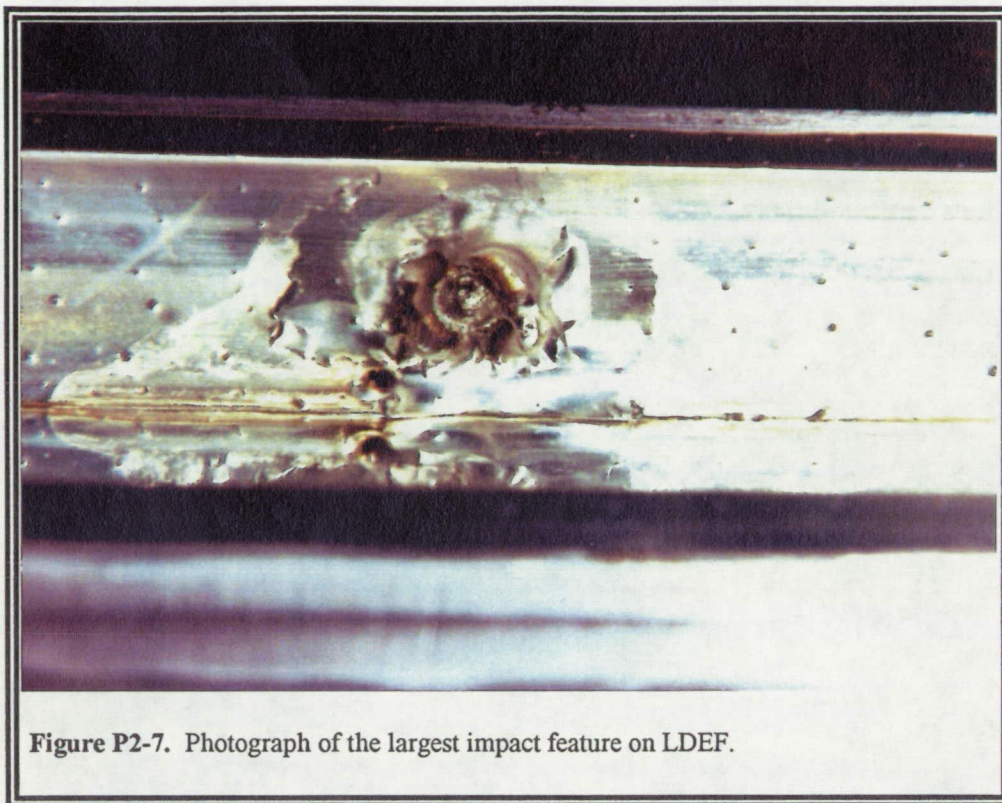
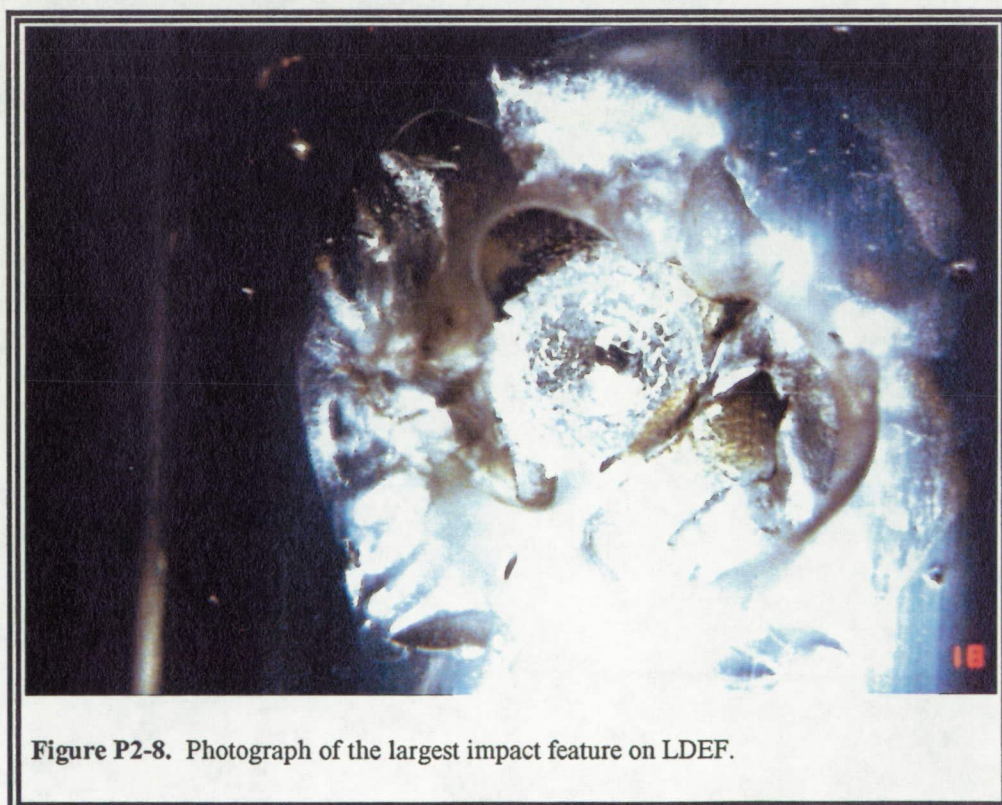
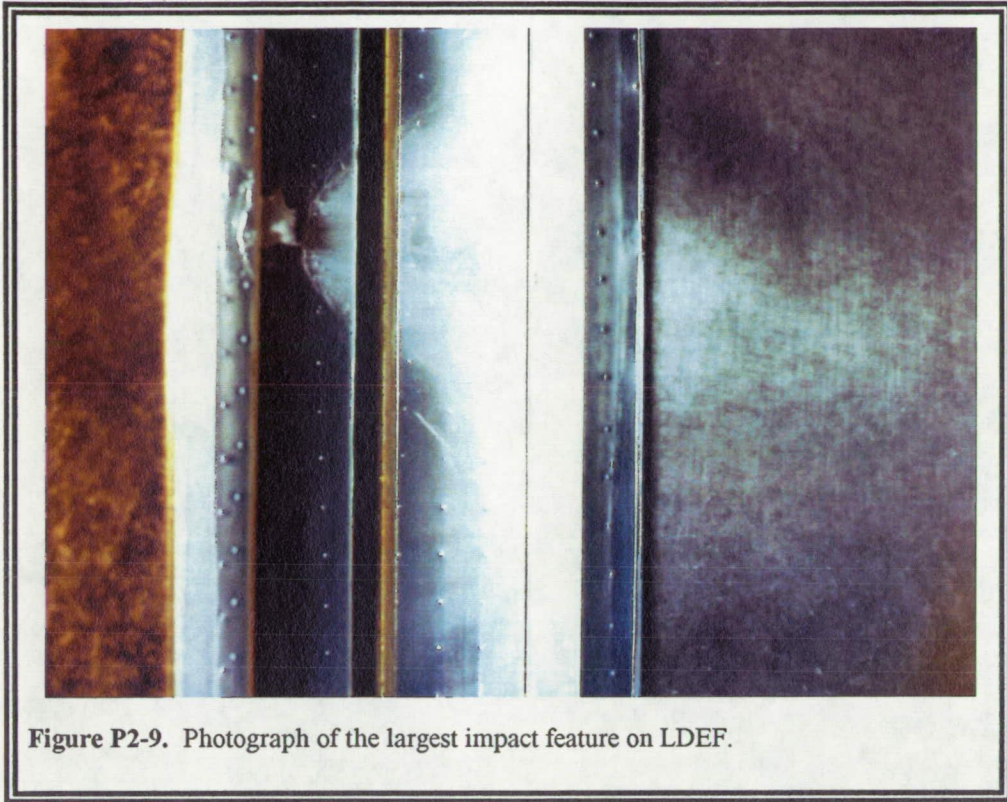
**Figures P2-7, P2-8, and P2-9 (KSC-390C-2033.10, S90-44921, and KSC-390C-1013.05)** are pictures of the largest impact on LDEF. This crater is 5.25 mm in diameter with a damage area which is over 5 cm in diameter. This crater is located on LDEF Bay H03 in the side of a structural aluminum "Z-frame" in the valley between two experiments. The surface of the Z-frame was aluminum which had been covered with a silvered-Teflon, adhesively-bonded thermal control tape. The entire Z-frame was backed with a solid block of aluminum which held the main experiment. This Z-frame side faced the RAM direction, but was located on the space-facing end of LDEF. In order to impact within this geometry, the particle would have to have been in an elliptical orbit. Figure P2-7 shows a very large delamination area caused by the crater. This is a delamination in the silvered-Teflon. Here, the Teflon delaminated from the silver and the silver delaminated from the aluminum substrate. There are large melted Teflon crater lips, shown in Figure P2-8, where the Teflon was melted and blown out like a volcano from the underlying surface. The large (5.25 mm) crater caused a large bulge in the back surface of the Z-frame and, had it not been for the backing block of aluminum, would have penetrated all the way through the Z-frame. If it was a piece of debris, as suspected, the impacting particle was approximately 0.9 mm in diameter (Ref. 8). Figure P2-9 shows the geometry of this impact feature, the height of the Teflon crater lips, and the extent of the ejecta spray which came from the Teflon, the underlying aluminum, and the impactor. The ejecta sprayed over a 20 cm wide swath across the adjacent surfaces. In typical satellite structural materials with wall thicknesses of less than 2.5 mm, this would have been a penetration with subsequent damage to internal components, possibly causing component failure.

Figure P2-7. Photograph of the largest impact feature on LDEF.

Figure P2-8. Photograph of the largest impact feature on LDEF.

**Figure P2-9.** Photograph of the largest impact feature on LDEF.

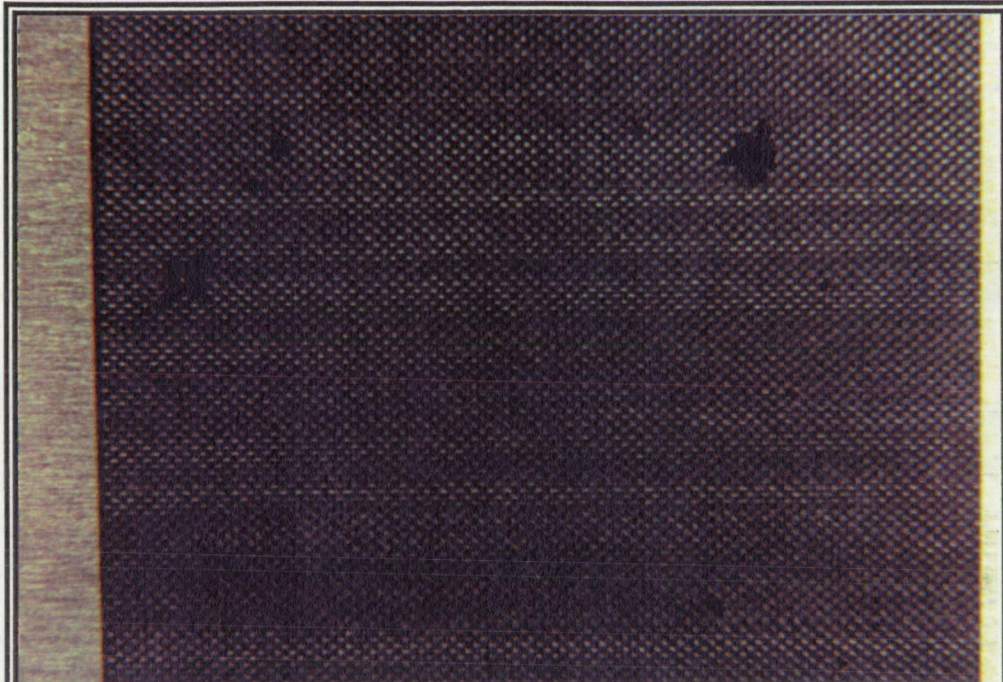
For the more brittle composite structural materials, the damage is rarely a simple crater. Rather, significant in-depth damage can occur and may be anisotropic, following the structure of fibers, etc. For complete penetrations the rear surface damage area is frequently larger than the entry hole area. This impact damage is of concern because the breaking of the fibers, cracking of the matrix, and removal of part of the matrix via the spallation process could cause failure in highly stressed components. This could also lead to further breakdown of the composite material during subsequent exposure to other space environments such as atomic oxygen or ultraviolet light.

**Figure P2-10.** Photograph of an impact feature in graphite-epoxy.

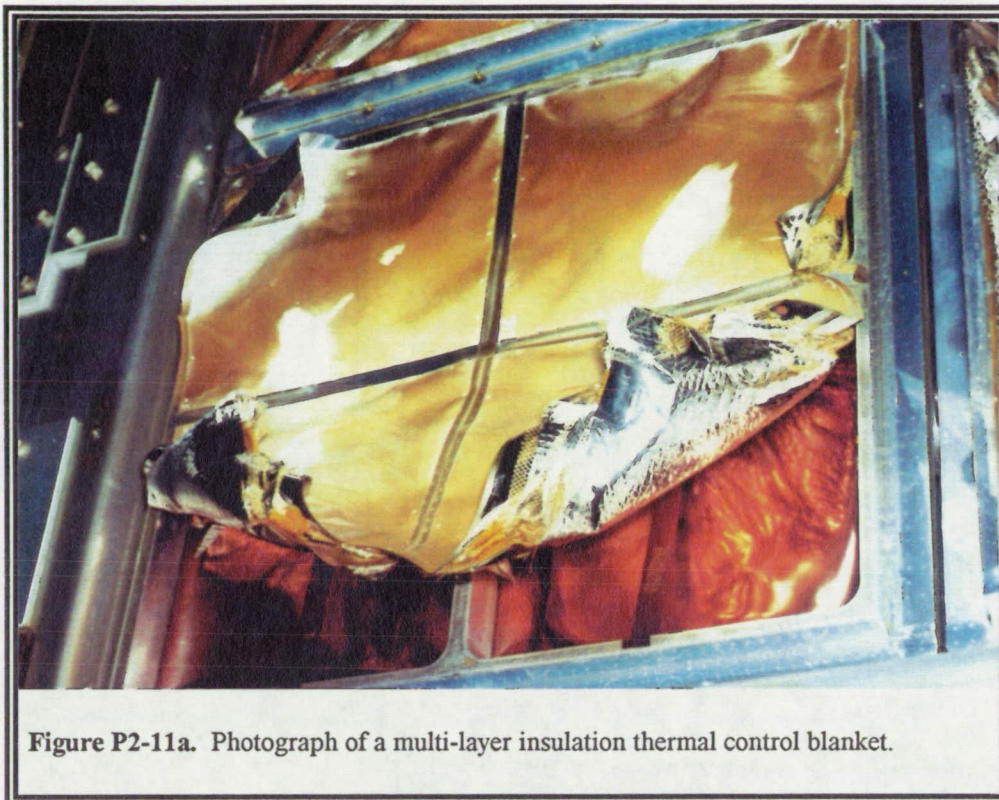
**Figure P2-11a (KSC-390C-828.06)** shows the multi-layer insulation (MLI) thermal control blankets which were located on the space end of LDEF at LDEF Bays H03 and H12. The top-most layer of these blankets was painted with a white thermal control paint (Chemglaze A276). After being subjected to the UV light in space, the binder in the paint turned brown. The blankets were attached to the experiment trays by Kapton tape and this tape became embrittled by the UV. Thermal cycling and subsequent cracking of the tape allowed the blankets to lift and curl back, subjecting parts of the blanket to AO from the RAM direction and creating the white stripes in the photograph. These white stripes are where the binder was eroded by the AO, leaving behind only the white pigment particles. **Figure P2-11b (KSC-390C-1013.01)** shows an impact into the underlying exposed Lexan which had turned dark brown and become brittle from the UV light. This view measures ~8 cm across. Note the extremely long cracks propagating from the impact crater.

Figure P2-11a. Photograph of a multi-layer insulation thermal control blanket.

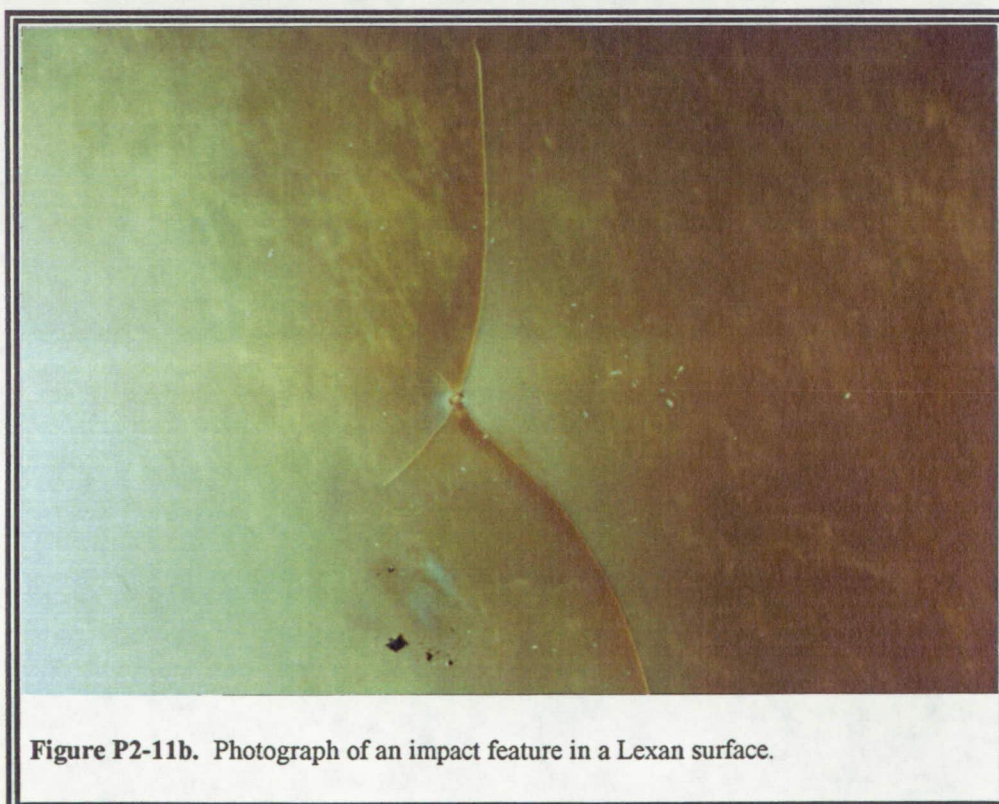
Figure P2-11b. Photograph of an impact feature in a Lexan surface.

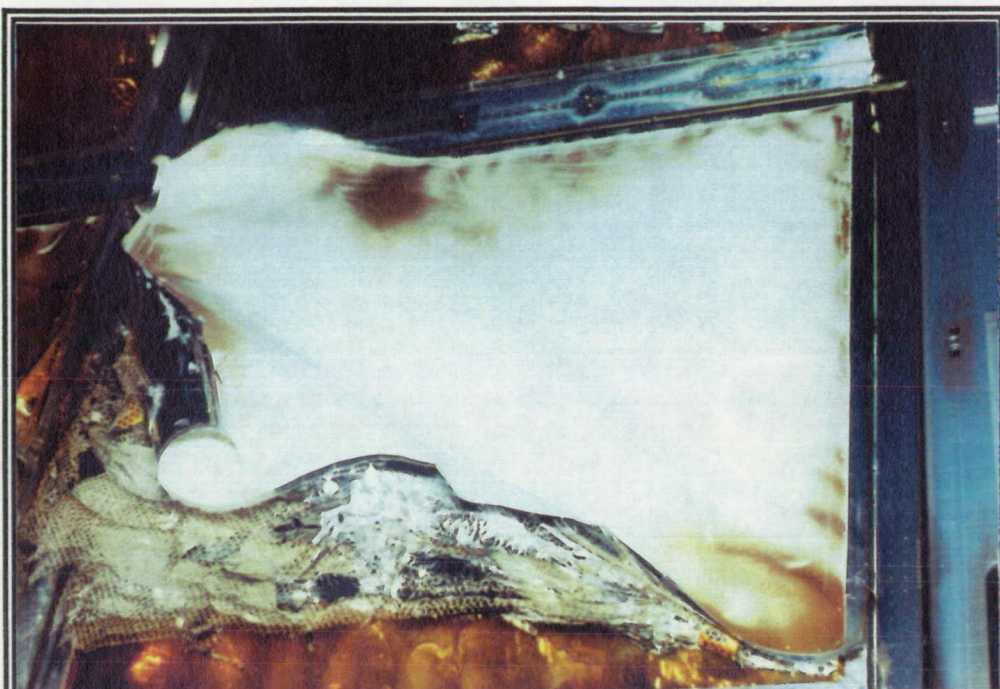
**Figure P2-12 (KSC-390C-828.05)** shows a more extensive version of the damage to the MLI shown in Figure P2-11a. The entire surface has been eroded by AO leaving almost none of the UV discolored binder. It is also interesting to note that these thermal control blankets were composed of very thin layers (approximately 22) of aluminum separated by layers of Dacron mesh. This photograph clearly shows the aluminum and Dacron mesh layers and how they began to come apart in the space environment.

**Figure P2-12.** Photograph of a multi-layer insulation thermal control blanket.

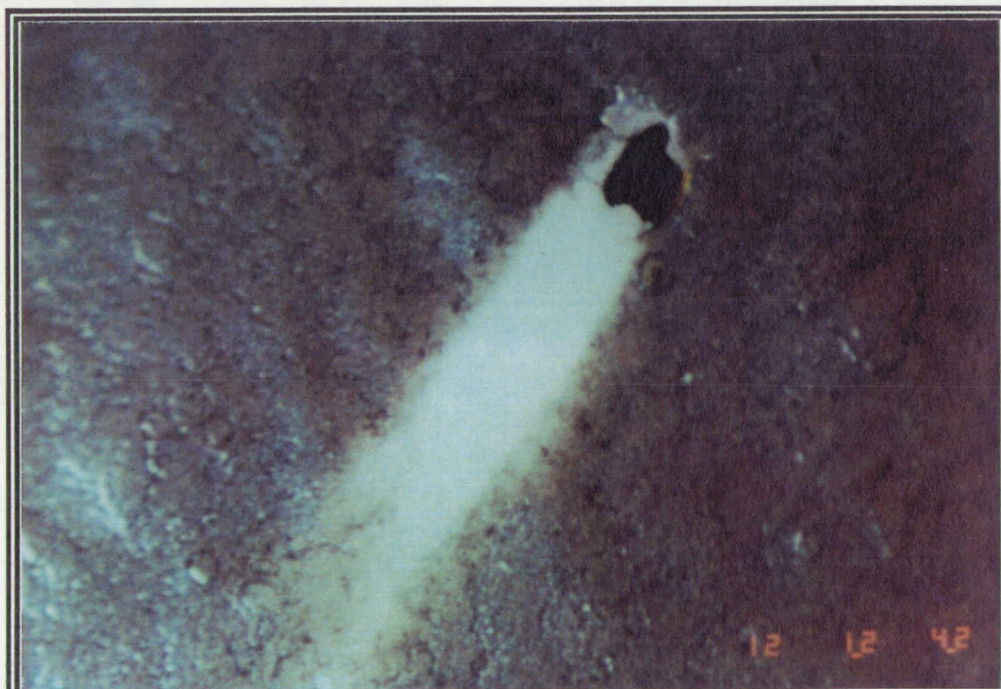
**Figure P2-13 (S90-44950)** is a picture of an impact into the MLI thermal control blanket, described previously for Figures P2-11 & 12, located at LDEF Bay H12. This close-up photograph shows a total view measuring ~2 cm. In this area, the paint has changed colors due to

**Figure P2-13.** Photograph of an impact feature in a multi-layer insulation thermal control blanket.

UV and AO exposure, followed by a penetration through the top surface. This penetration caused typical tearing in the thin metal substrate as well as spallation of the paint surface and subsequent degradation from the particle ejecta. This impact was most likely a highly-oblique impact with much of the surrounding paint pigment and surface material being blown off by the impact ejecta.

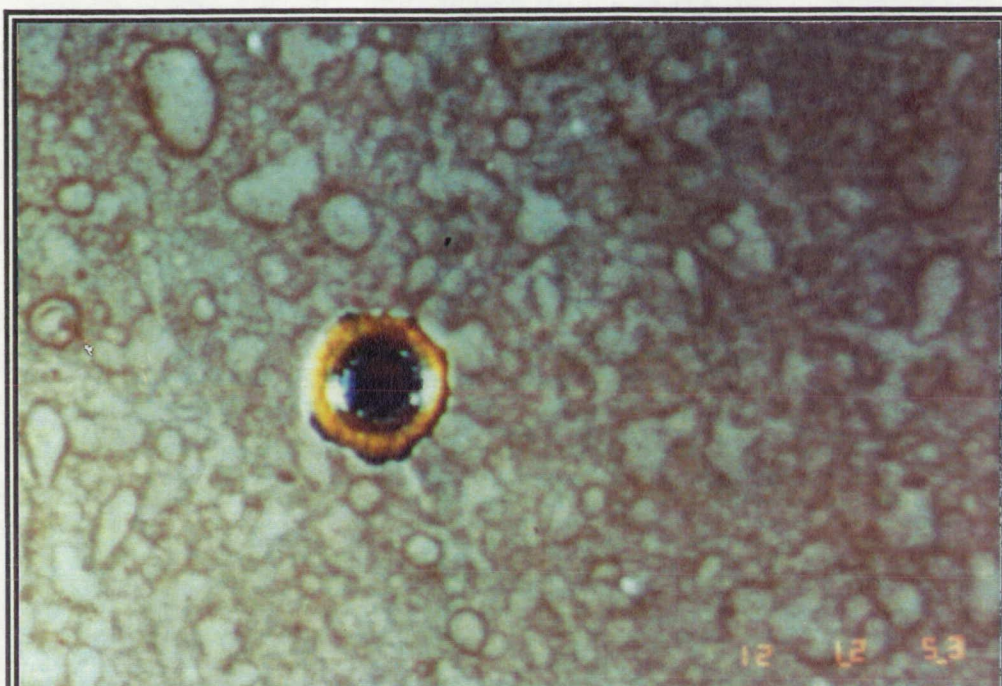
**Figure P2-14 (S90-44934)** is another typical impact into these types of MLI. The "splotchy" area around the impact penetration is the thermal control paint with alternating patches of pigment particles and discolored binder. The impact penetration shows well defined lips in the metalized Mylar with spallation of paint from the surrounding material. The subsequent layers are not shown here, but the pressure pulse, combined with the spray of ejecta from this penetration, continued to damage multiple layers below the impact and the penetration hole size continued to expand through these subsequent layers. Depending on the impactor diameter, velocity, and material, it is possible to penetrate through all the layers of the MLI. An interesting note was that the Dacron mesh was often not penetrated itself, but rather left a protective shadow on the underlying layers.

**Figure P2-14.** Photograph of an impact feature in a multi-layer insulation thermal control blanket.

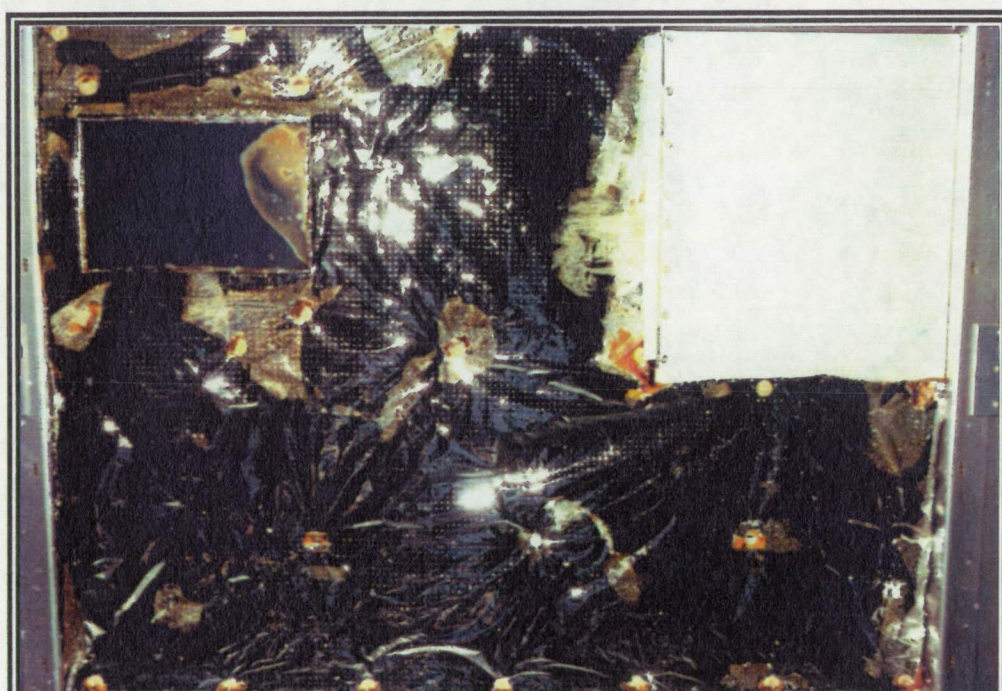
**Figures P2-15a, P2-15b, and P2-15c (KSC-390C-2157.3, KSC-390C-2116.12, and KSC-390C-1770.4)** show the extent of damage caused by the synergisms of the space environment. Figure P2-15a is a photograph of an MLI from tray F09 on the leading edge of LDEF. The top surface of Mylar was completely eroded, exposing the interior surfaces to UV light, AO and thermal cycling. Due to exposure to these environments, the aluminum layers tended to break up into small pieces creating a shower of fine particles which went into orbit around the Earth in conjunction with LDEF. This created a type of atmosphere of fine particulates which completely surrounded LDEF and became an extreme contamination source for the entire satellite.

**Figure P2-15a.** Photograph of a multi-layer insulation thermal control blanket.

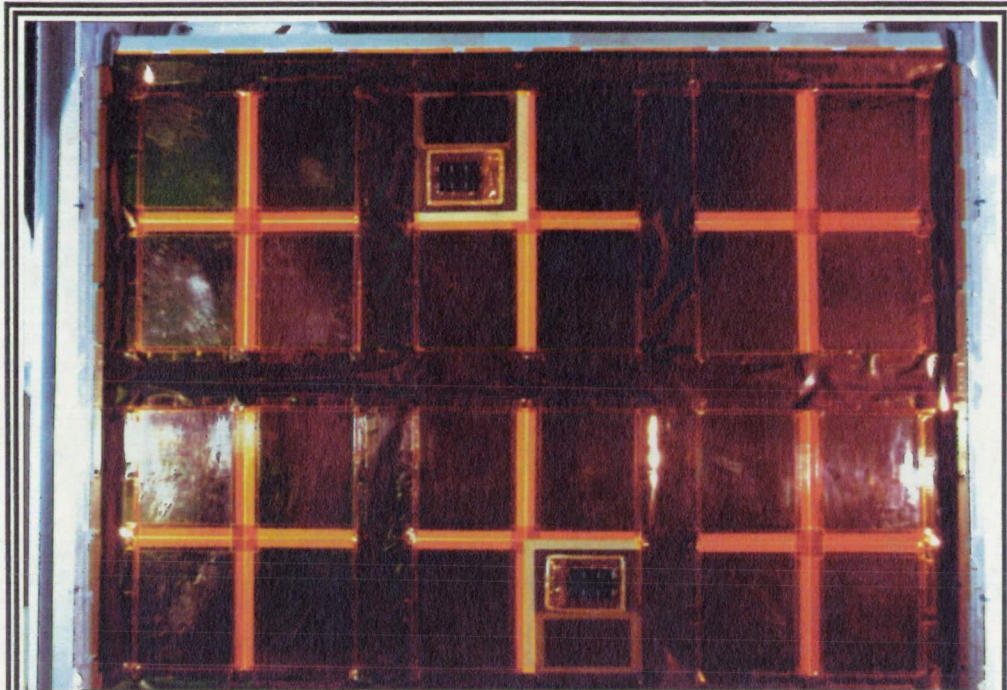
An even worse situation was created by the degradation of the aluminized Kapton which covered experiment A0054. Figure P2-15b shows the A0054 experiment which flew on the trailing edge at LDEF Bay B04. The aluminized Kapton was essentially unchanged from pre-flight.

**Figure P2-15b.** Photograph of post-deintegration view of the entire B04 experiment tray.

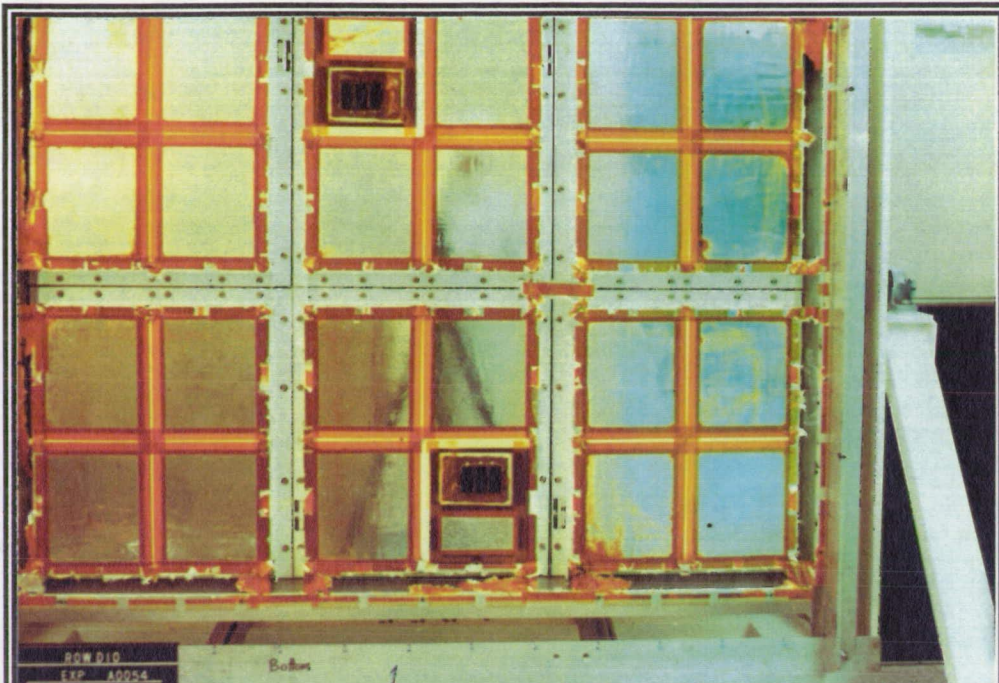
**Figure P2-15c.** Photograph of post-deintegration view of the entire D10 experiment tray.

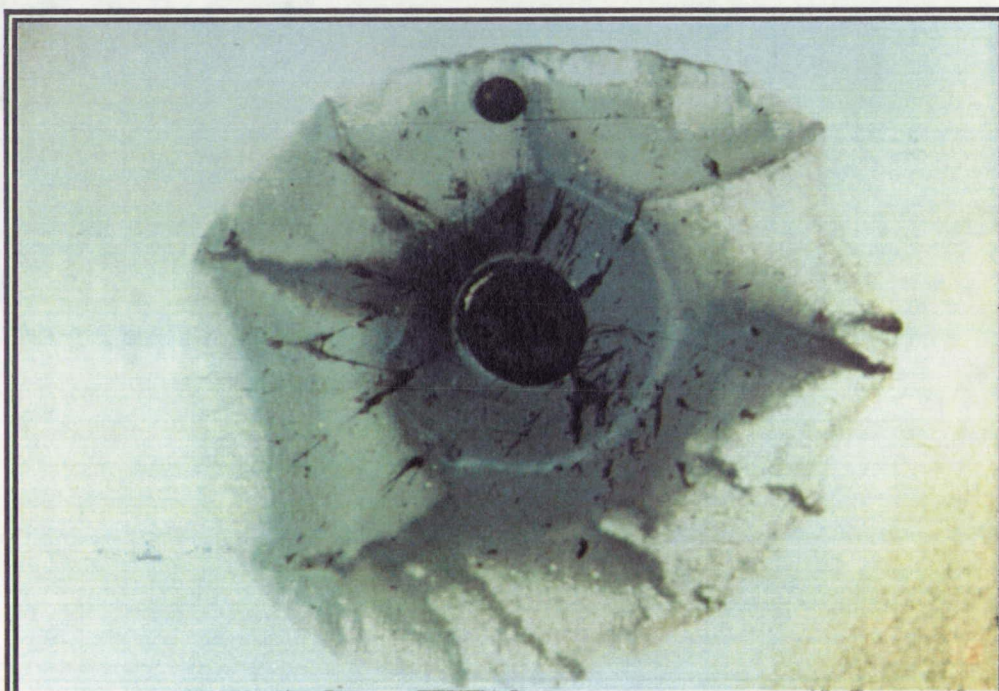
Figures P2-16 and P2-17 (S90-45000 and S90-45015) are photographs of the same penetration but from opposite sides of the material. The penetration is through an aluminized-Mylar foil. Figure P2-16 shows the front surface with the typical penetration through the Mylar leaving a large, slightly upraised area which delaminated from the lower aluminum. The penetration shows the typical large melted lips in the Mylar. Figure P2-17 shows the back surface of the aluminum. In the central area the penetration hole can be seen along with the melted lips of the Mylar and a large spallation area in the aluminum. In the delamination zone, the aluminum has cracked and petaled outwards from the spallation zone. This effect produced a large damage area ~8 times the diameter of the penetration in the Mylar.

**Figure P2-16.** Photograph of the front surface of an impact penetration through an aluminized-Mylar foil.

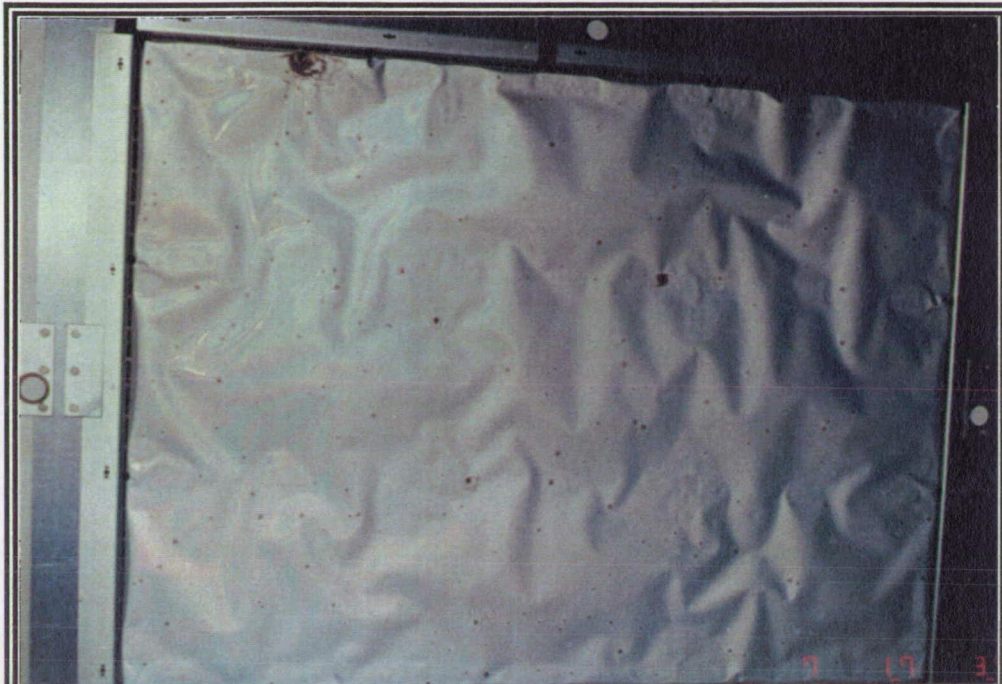
Figure P2-19 (S90-43399) is a picture of an entire LDEF A0178 thermal control blanket. These were silvered-Teflon blankets (Scheldahl G411500) with a back surface coating of Chemglaze Z306 black paint. The approximate thickness of the blanket was 200 microns. The picture is of the thermal blanket still attached to the experiment on LDEF. Notice the number of black dots. Each of these dots is a penetration through the Teflon, allowing access of AO to the silver layer. Instead of being reflective (as on pre-flight) the entire blanket is very milky in color. This is

**Figure P2-19.** Photograph of post-deintegration view of an entire A0178 experiment tray (Scheldahl thermal control blanket).

caused by the high amount of light scattering from the newly textured surface of the Teflon. The Teflon surface was textured by AO erosion.

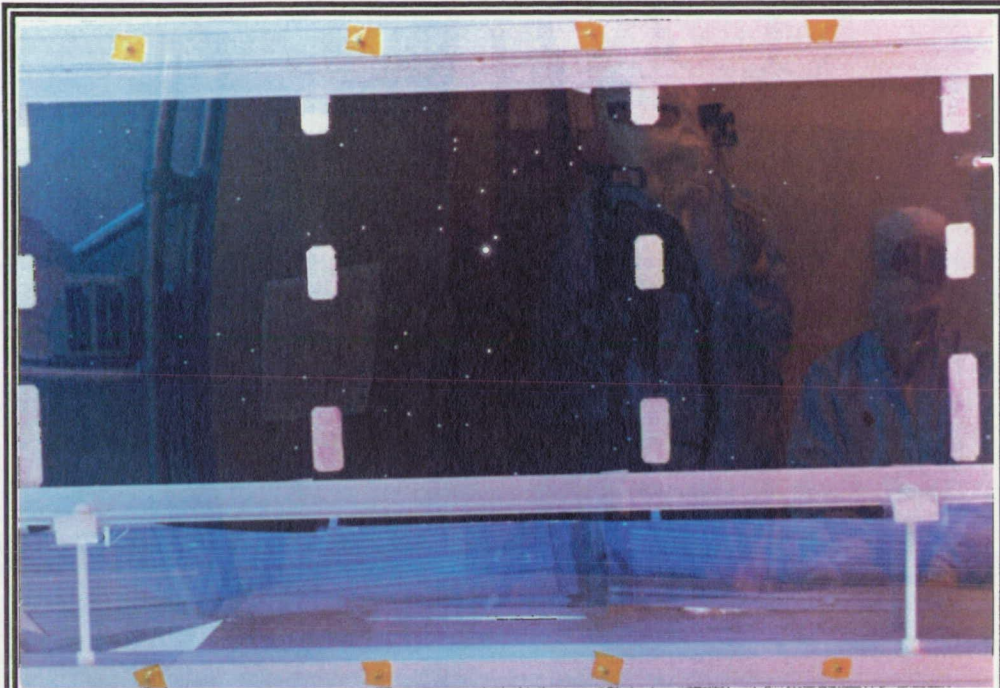
**Figure P2-20.** Photograph of the back surface of a Scheldahl G411500 silvered-Teflon thermal control blanket.

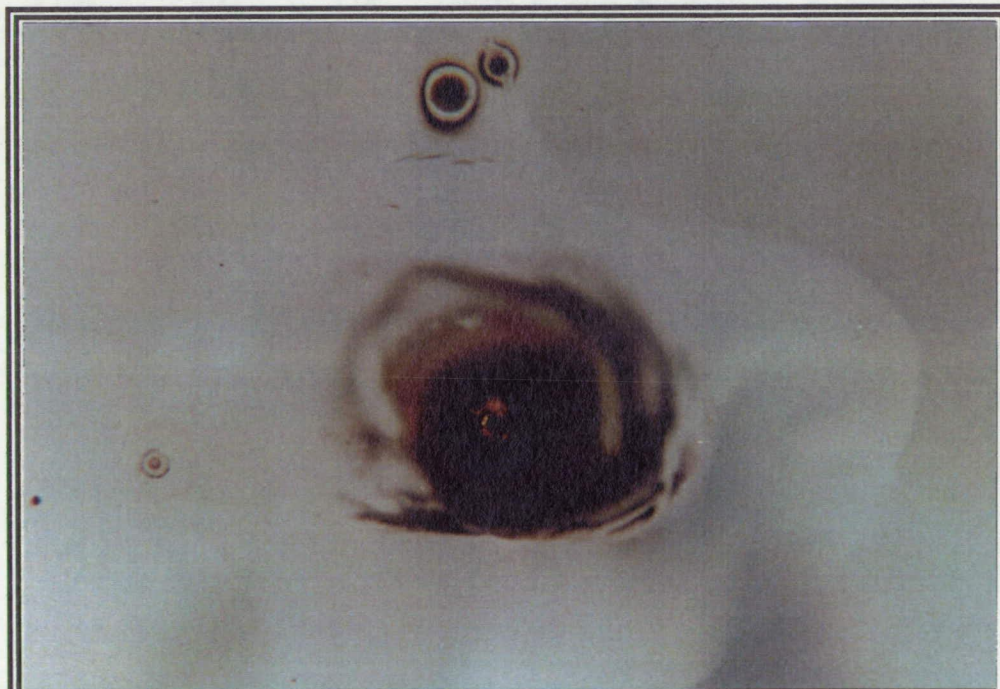
**Figure P2-21.** Photograph of a large impact penetration through a Scheldahl G411500 silvered-Teflon thermal control blanket.

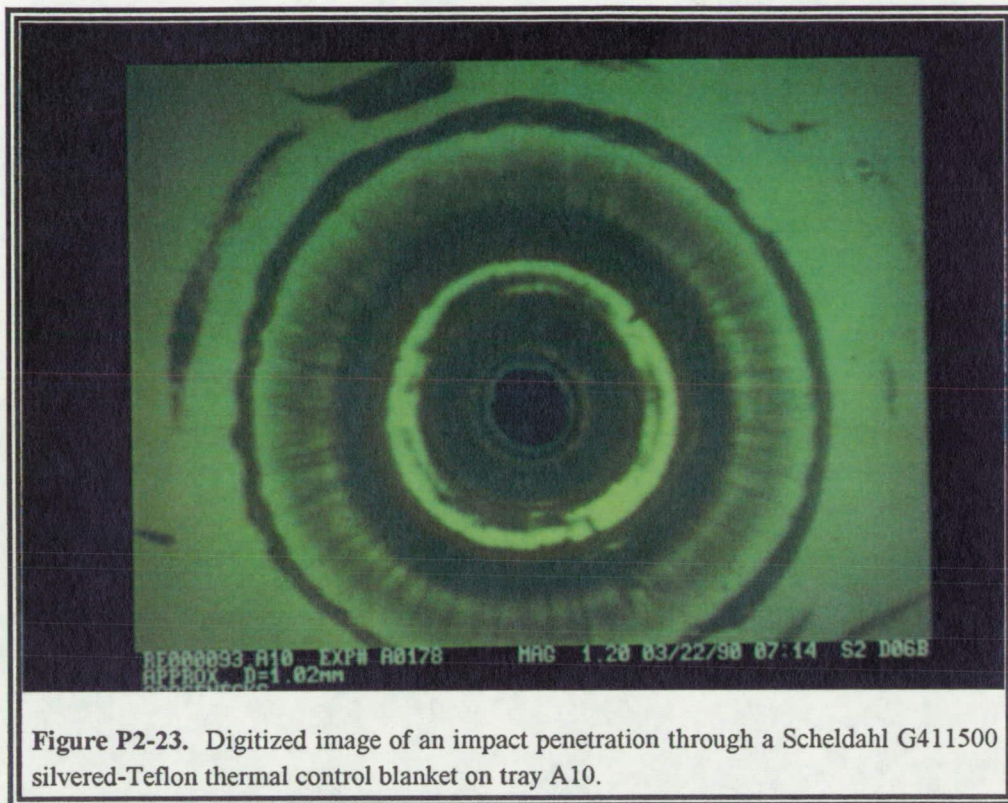
**Figure P2-23.** Digitized image of an impact penetration through a Scheldahl G411500 silvered-Teflon thermal control blanket on tray A10.

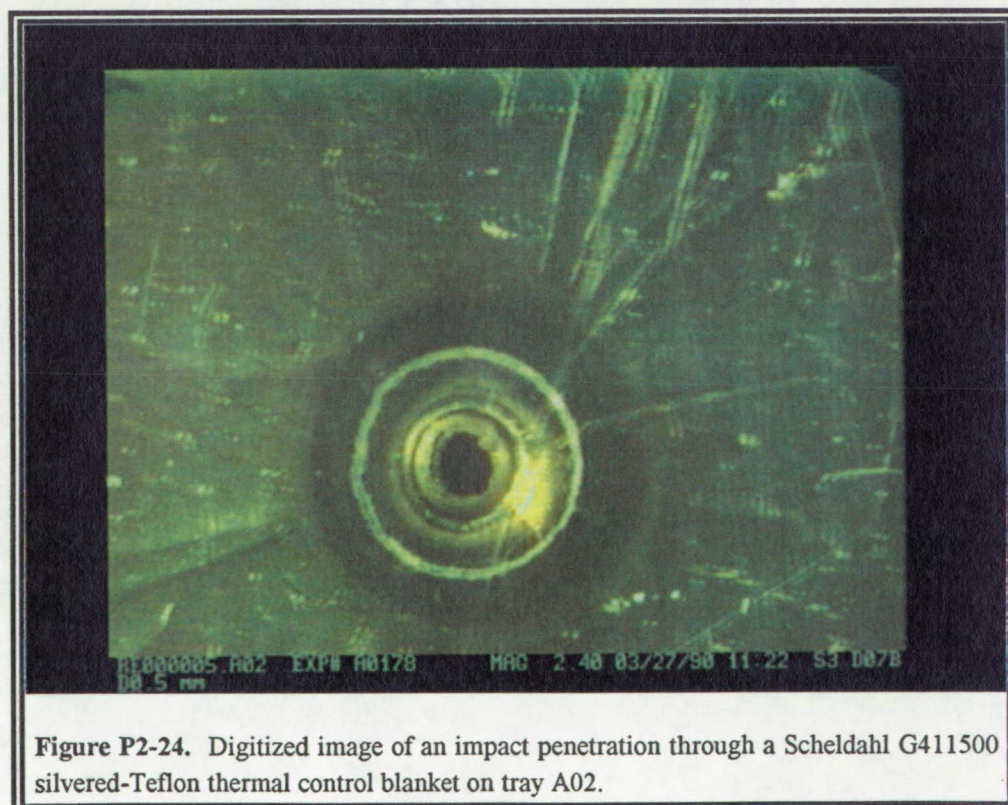
**Figure P2-24.** Digitized image of an impact penetration through a Scheldahl G411500 silvered-Teflon thermal control blanket on tray A02.

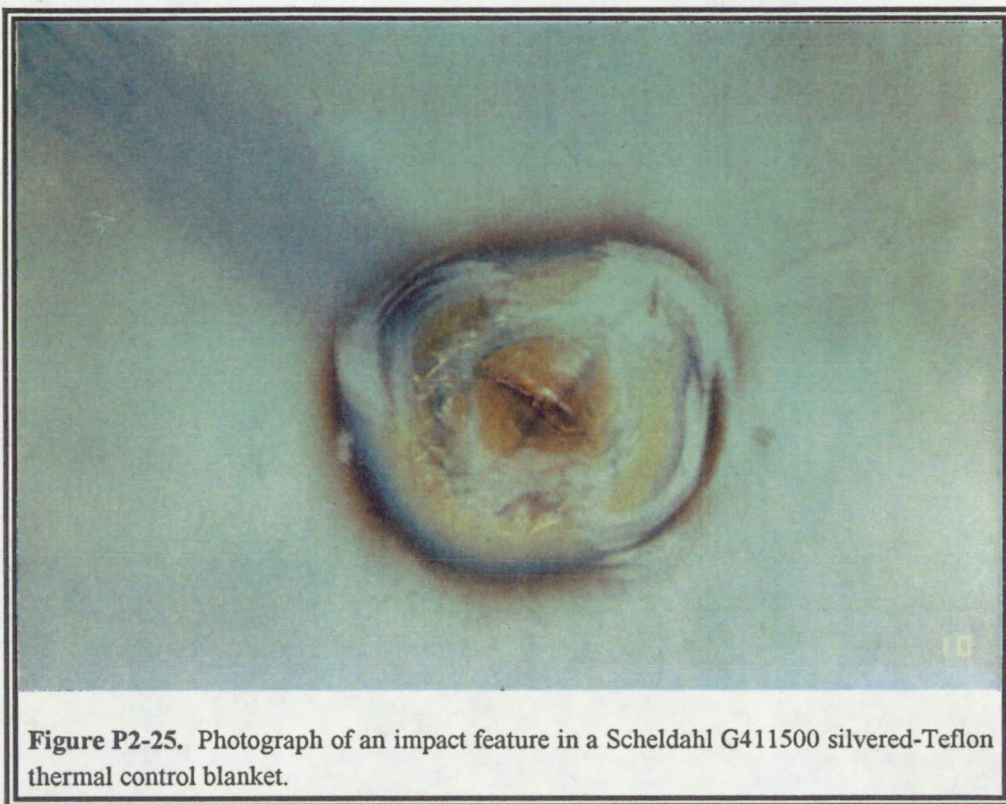
**Figure P2-25 (S90-44988)** shows an impact, probably at a highly-oblique angle, into the A0178 Teflon blankets. This impact did not penetrate all the way through the blankets but instead cratered the surface. This caused a delamination between the Teflon and the silver and a large amount of ejecta (in the upper left corner) sprayed across the surface of the Teflon. The underlying silver had very little AO erosion.

**Figure P2-25.** Photograph of an impact feature in a Scheldahl G411500 silvered-Teflon thermal control blanket.

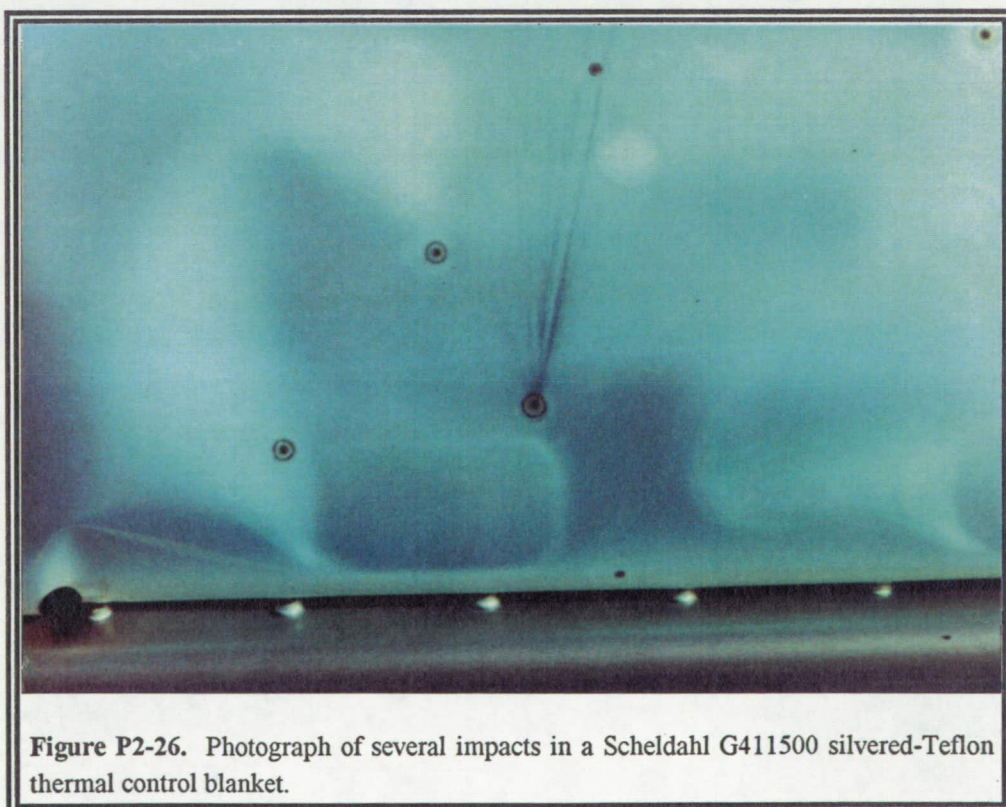
**Figure P2-26 (KSC-390C-1544.6)** is a combined picture of several impacts on the leading edge A0178 thermal control blanket from LDEF Bay C08. This picture shows several typical penetrations with their surrounding delamination areas and ring structures due to AO. In addition, there is a large spray feature which emanates from the lower central impact and goes towards the top of the picture. This spray passes right next to a delamination zone. This delamination zone was caused by a crater which did not penetrate the Teflon, but created a large enough shock wave to cause a huge delamination between the Teflon, the silver, and the underlying black paint. This one image shows several different types of features and measures  $\sim 21$  cm across the total view.

**Figure P2-26.** Photograph of several impacts in a Scheldahl G411500 silvered-Teflon thermal control blanket.
